ANNUAL REPORT FOR 2004

Marks Creek Stream Mitigation Site

Wake County

Prepared By:
Office of Natural Environment & Roadside Environmental Unit
North Carolina Department of Transportation
March 2005

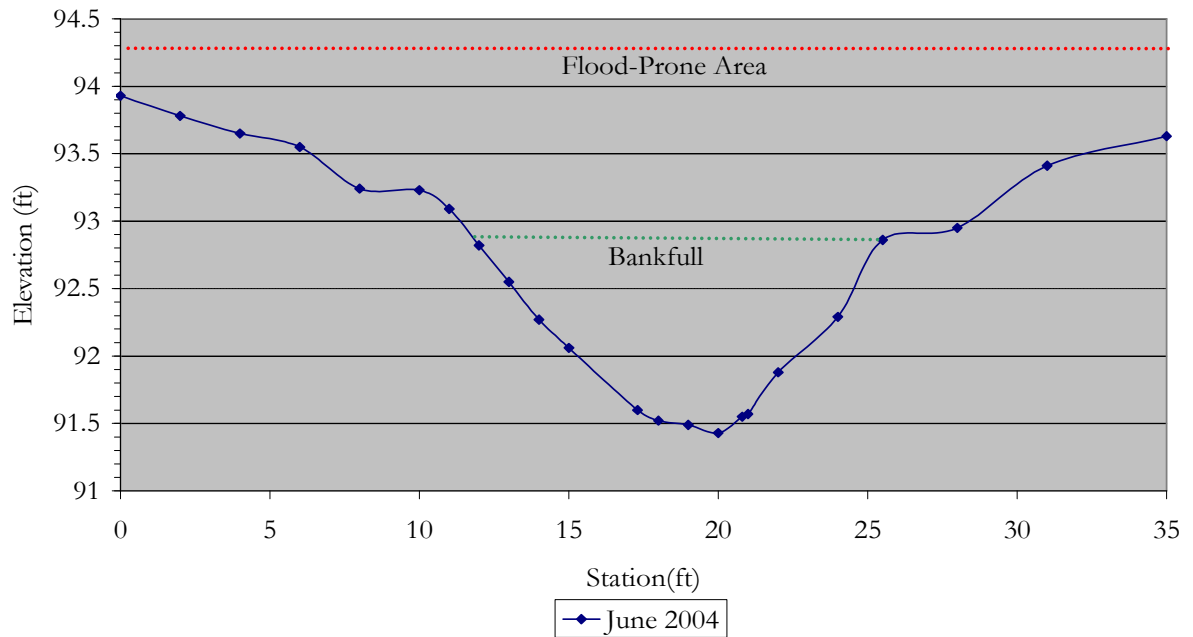
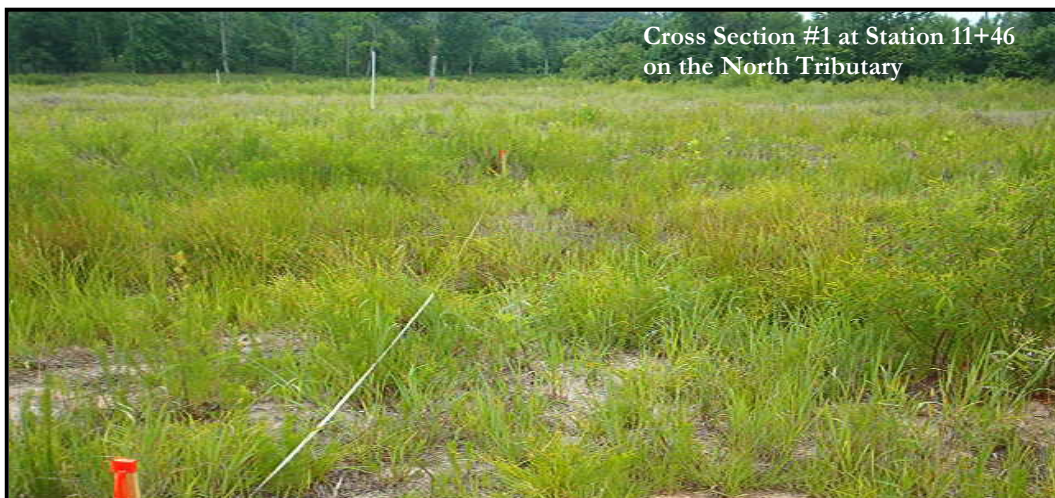
Cross Section #1, Station 11+46 (North Tributary)

2004	2005	2006	2007	2008
Bankfull Cross Sectional Area (ft ²)	12.2				
Maximum Bankfull Depth (ft)	1.4				
Width of the Floodprone Area (ft)	300				
Bankfull Mean Depth (ft)	0.9				
Width/Depth Ratio	15.8				
Entrenchment Ratio	22.1				
Bankfull Width (ft)	13.6

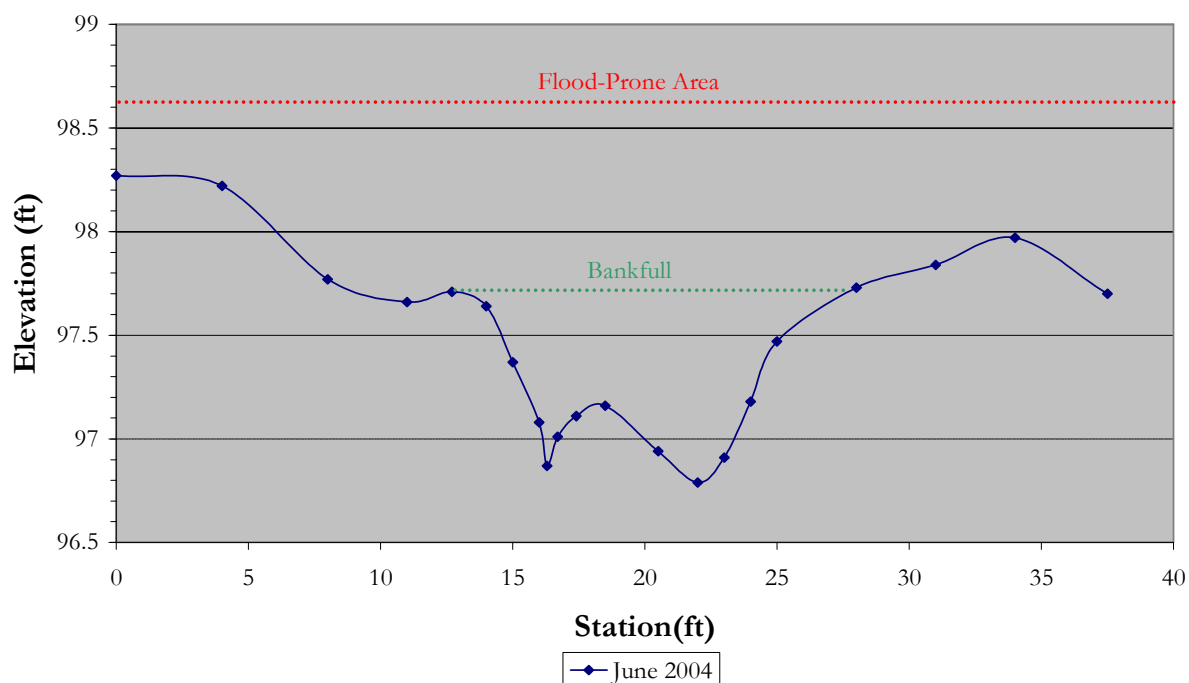
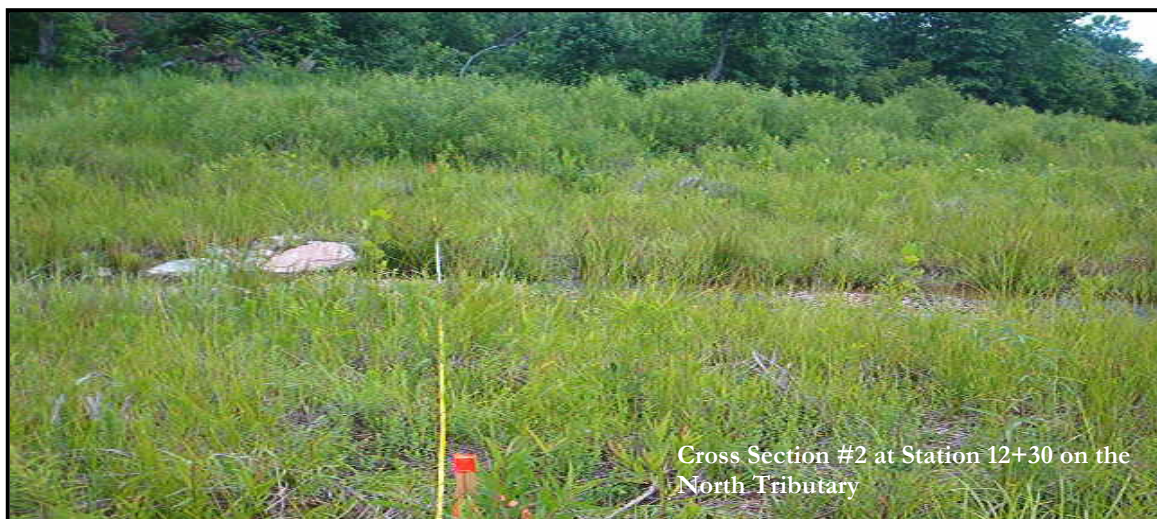
Cross Section #2, Station 12+30 (North Tributary)

2004	2005	2006	2007	2008
Bankfull Cross Sectional Area (ft ²)	7.6				
Maximum Bankfull Depth (ft)	0.9				
Width of the Floodprone Area (ft)	300				
Bankfull Mean Depth (ft)	0.5				
Width/Depth Ratio	30.4				
Entrenchment Ratio	19.7				
Bankfull Width (ft)	15.2

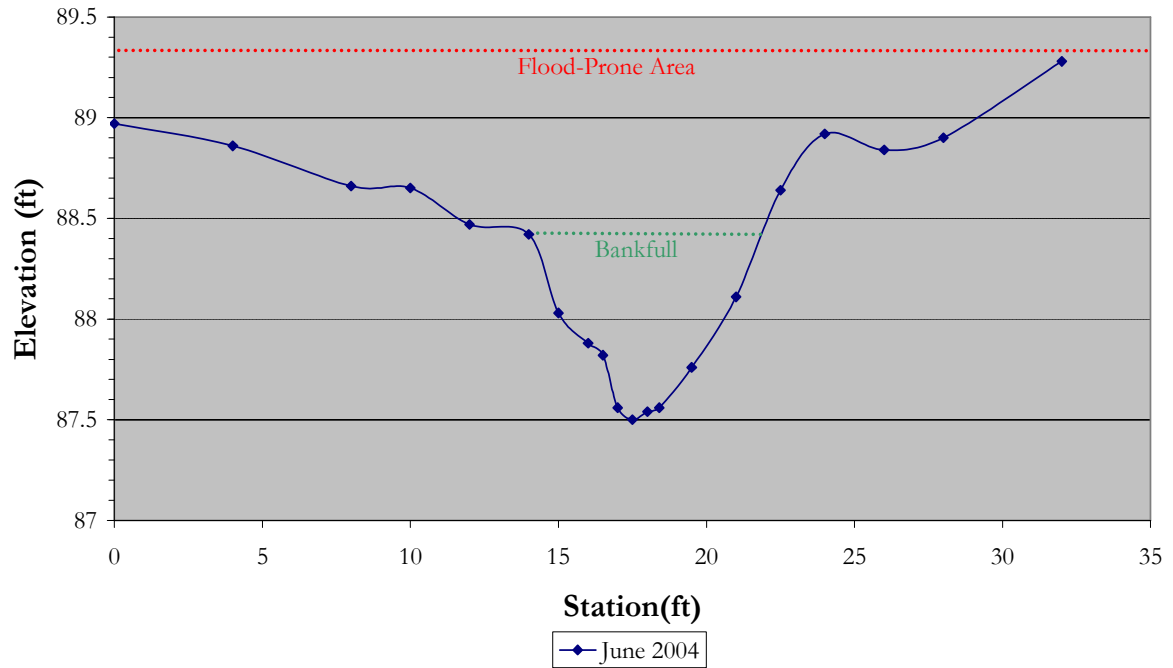
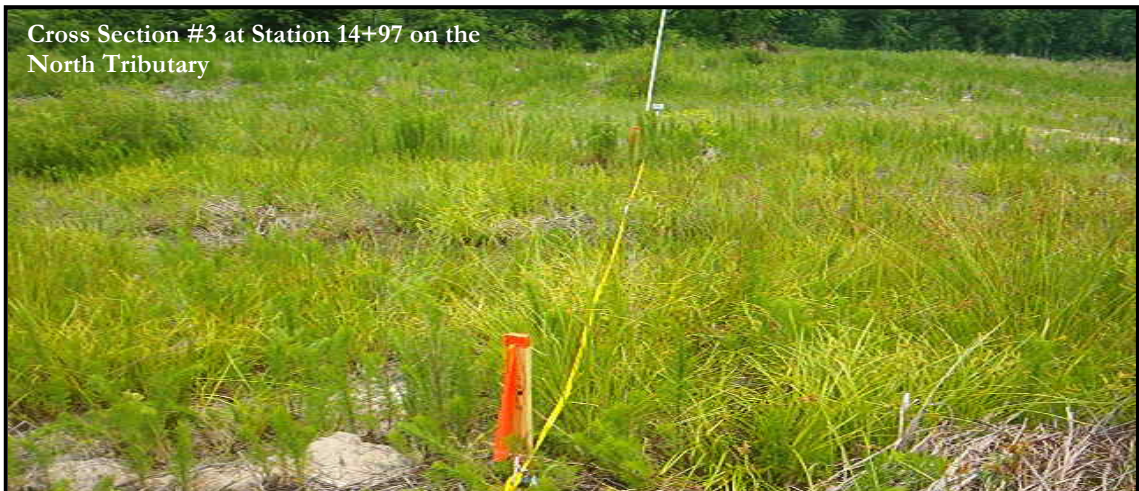
Cross Section #3, Station 14+97 (North Tributary)

2004	2005	2006	2007	2008
Bankfull Cross Sectional Area (ft ²)	4.0				
Maximum Bankfull Depth (ft)	0.9				
Width of the Floodprone Area (ft)	400				
Bankfull Mean Depth (ft)	0.5				
Width/Depth Ratio	15.8				
Entrenchment Ratio	50.6				
Bankfull Width (ft)	7.9

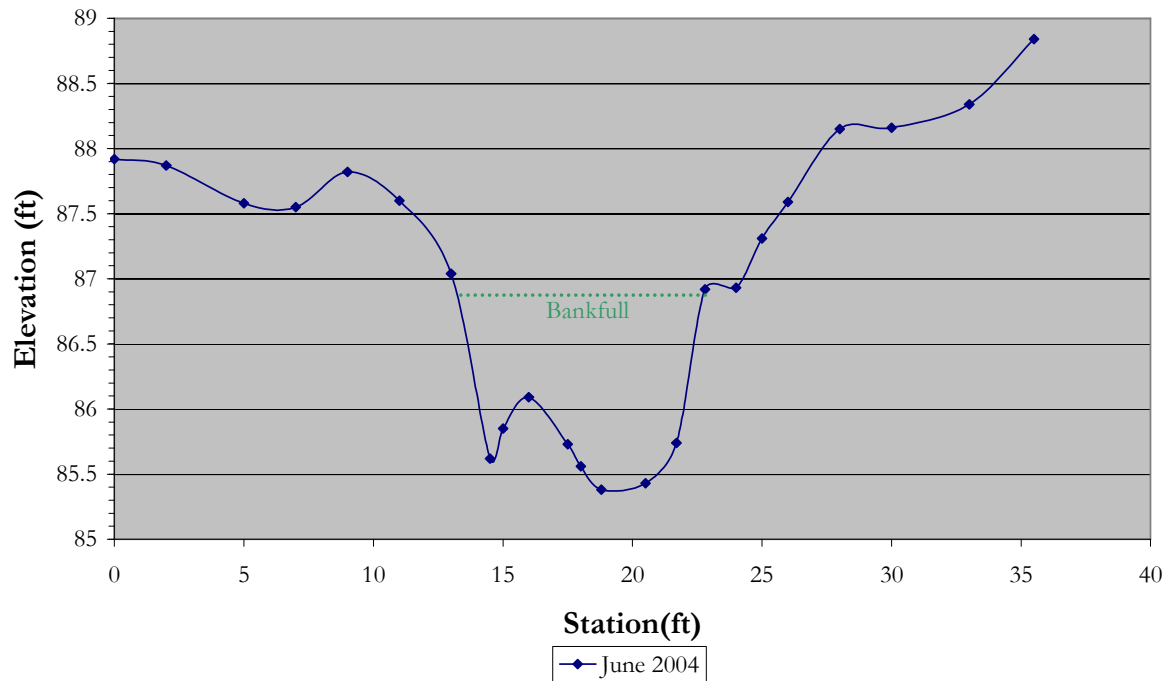
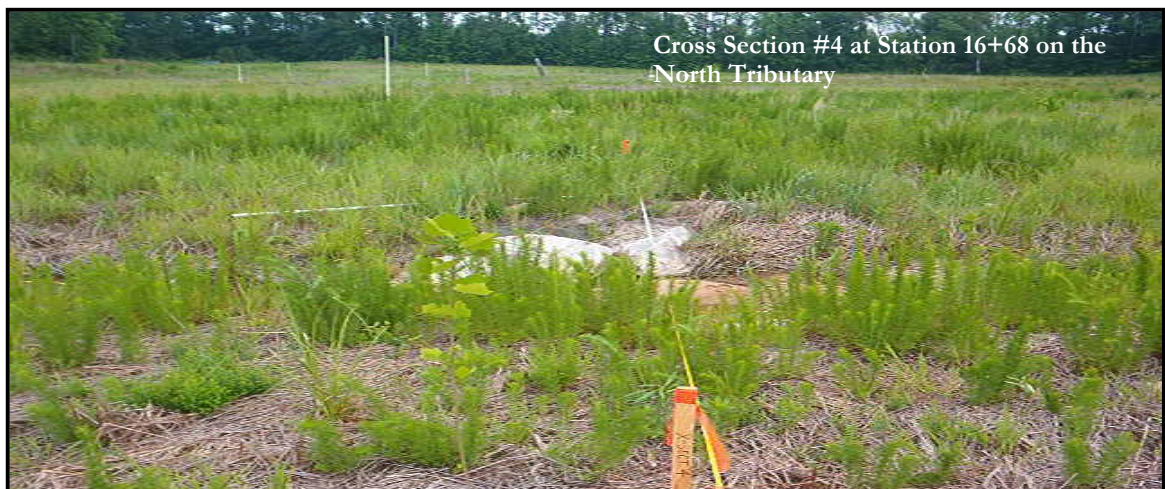
Cross Section #4, Station 16+68 (North Tributary)

2004	2005	2006	2007	2008
Bankfull Cross Sectional Area (ft ²)	10.6				
Maximum Bankfull Depth (ft)	1.5				
Bankfull Mean Depth (ft)	1.1				
Bankfull Width (ft)	9.6

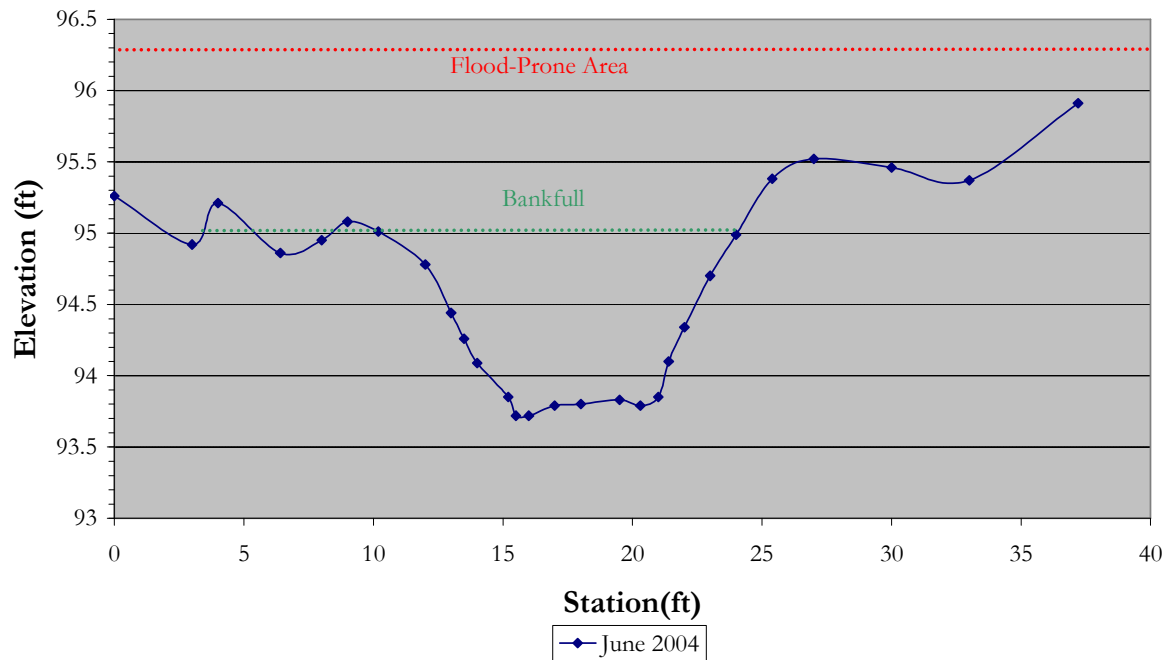
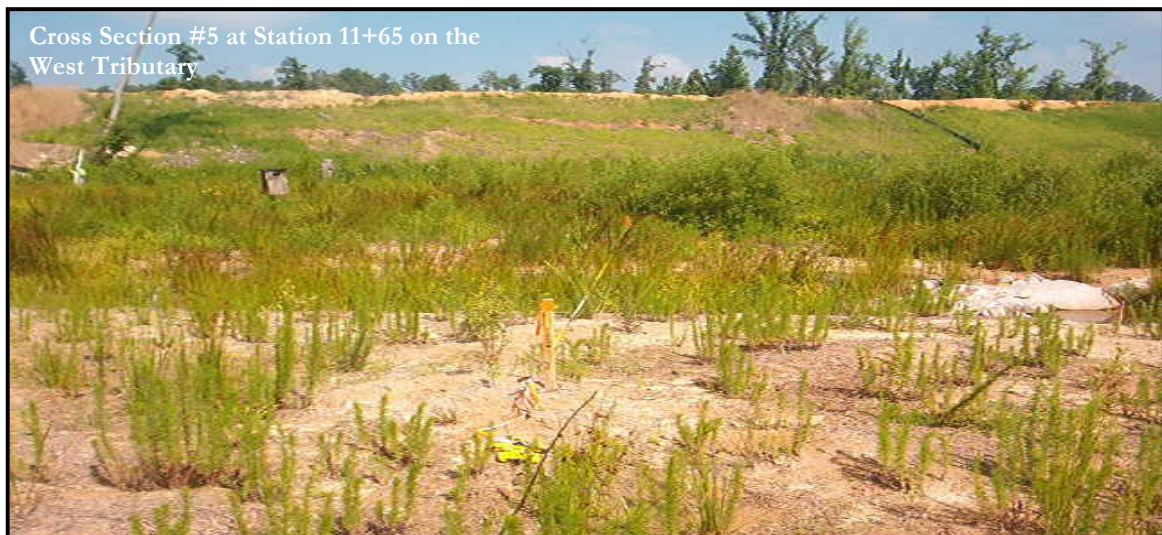
Cross Section #5, Station 11+65 (West Tributary)

2004	2005	2006	2007	2008
Bankfull Cross Sectional Area (ft ²)	11.3				
Maximum Bankfull Depth (ft)	1.3				
Width of the Floodprone Area (ft)	375				
Bankfull Mean Depth (ft)	0.8				
Width/Depth Ratio	17.6				
Entrenchment Ratio	26.6				
Bankfull Width (ft)	14.1

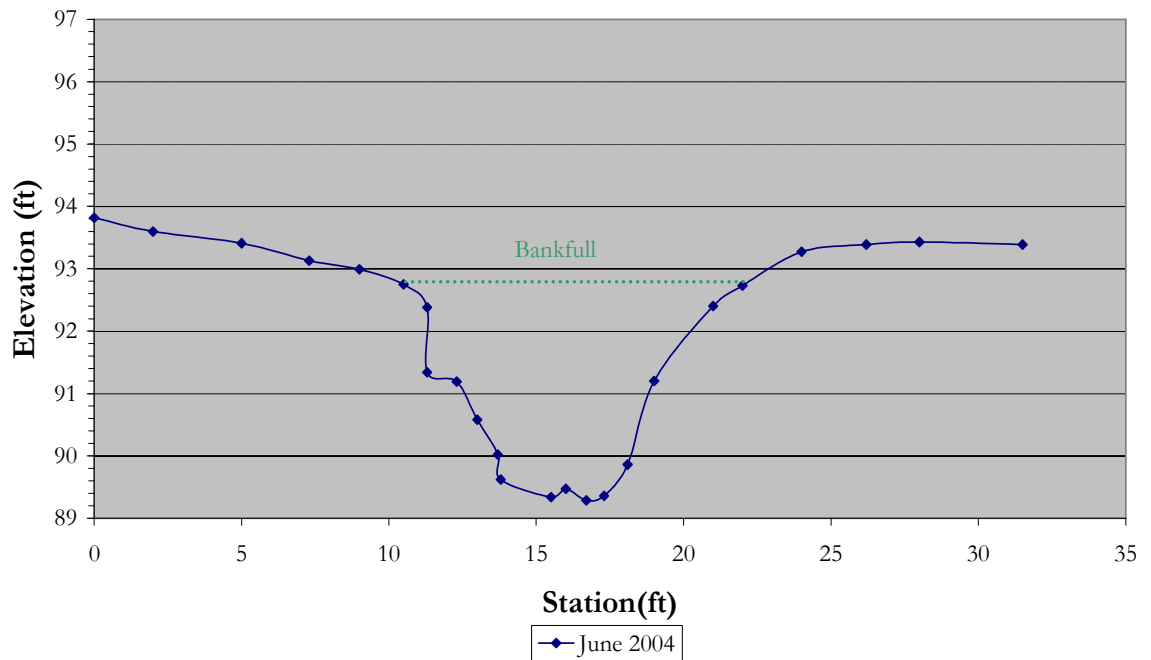
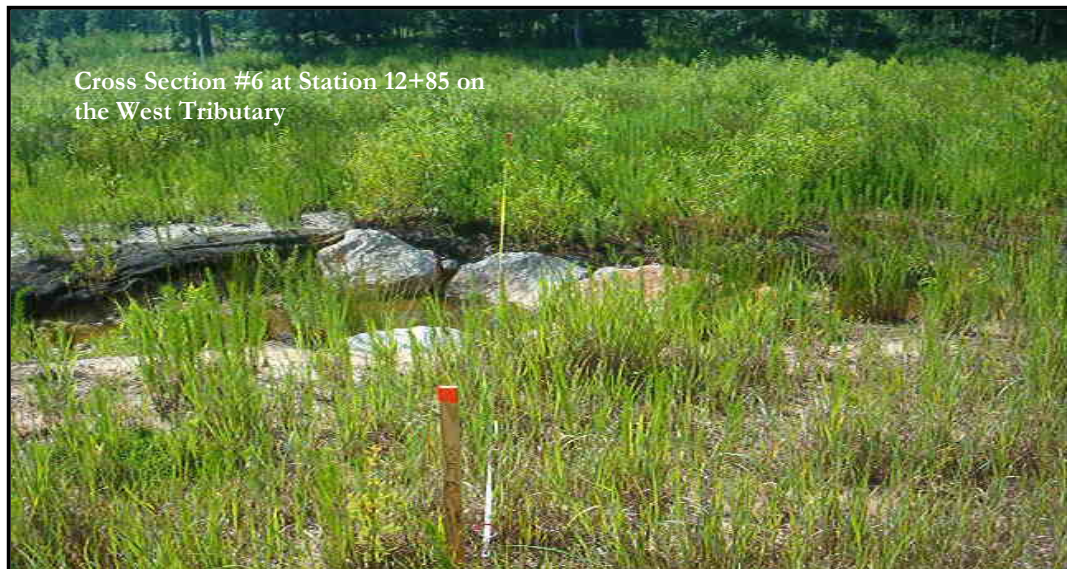
Cross Section #6, Station 12+85 (West Tributary)

2004	2005	2006	2007	2008
Bankfull Cross Sectional Area (ft ²)	23.0				
Maximum Bankfull Depth (ft)	3.4				
Bankfull Mean Depth (ft)	2.0				
Bankfull Width (ft)	11.5

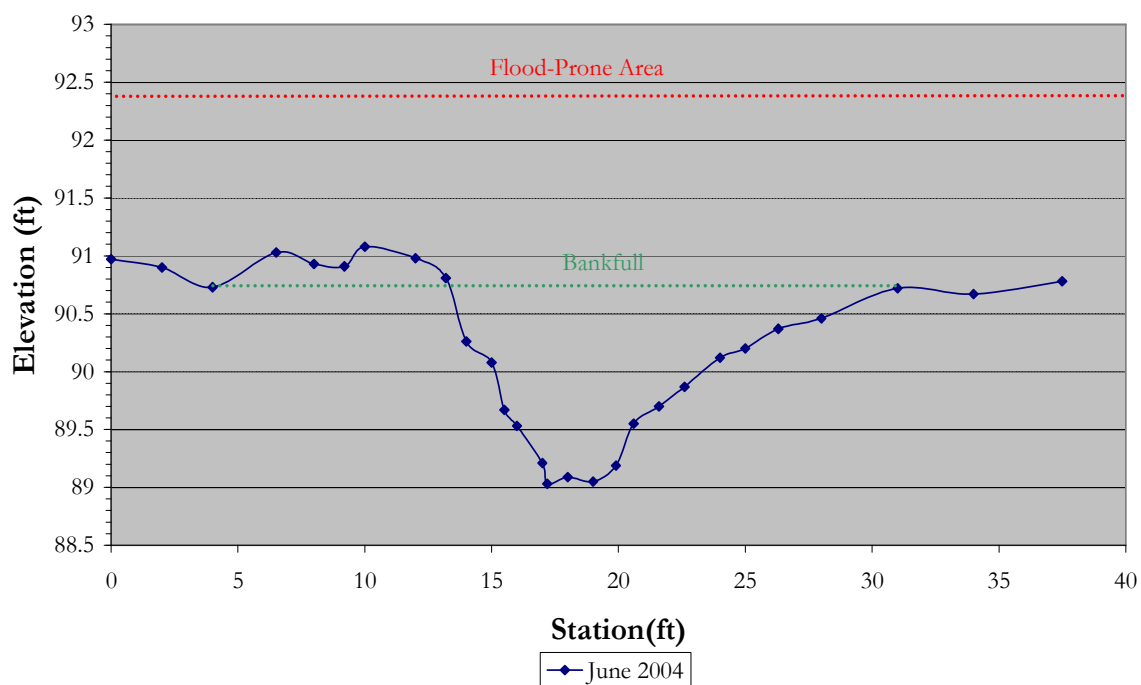
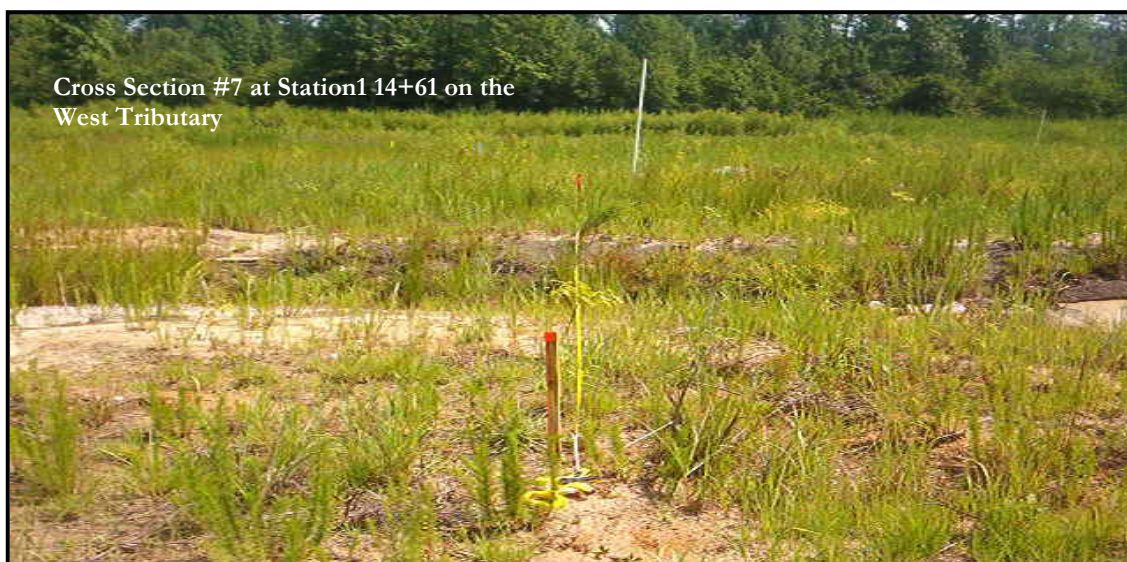
Cross Section #7, Station 14+61 (West Tributary)

2004	2005	2006	2007	2008
Bankfull Cross Sectional Area (ft ²)	13.4				
Maximum Bankfull Depth (ft)	1.7				
Width of the Floodprone Area (ft)	450				
Bankfull Mean Depth (ft)	0.6				
Width/Depth Ratio	37.2				
Entrenchment Ratio	20.2				
Bankfull Width (ft)	22.3

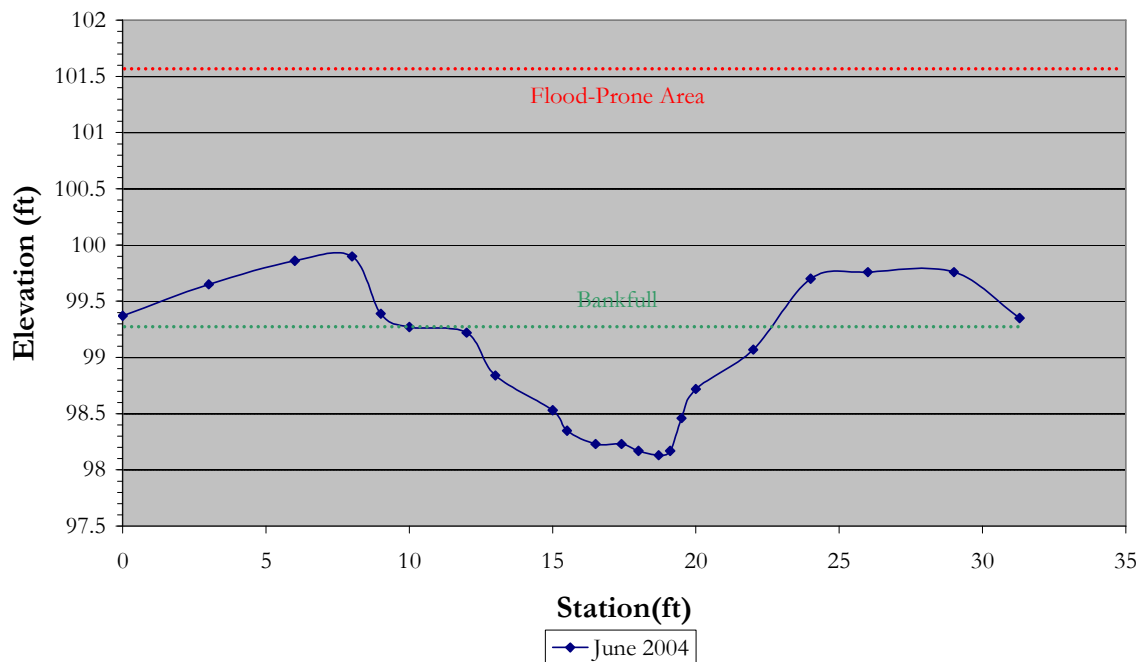
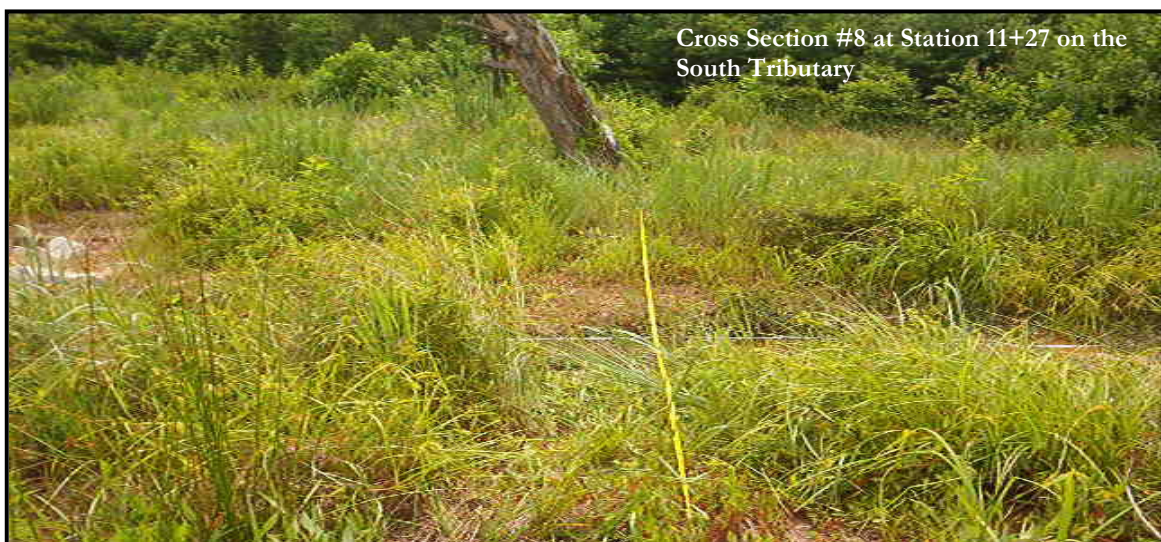
Cross Section #8, Station 11+27 (South Tributary)

2004	2005	2006	2007	2008
Bankfull Cross Sectional Area (ft ²)	6.3				
Maximum Bankfull Depth (ft)	1.1				
Width of the Floodprone Area (ft)	75.0				
Bankfull Mean Depth (ft)	0.6				
Width/Depth Ratio	17.5				
Entrenchment Ratio	7.1				
Bankfull Width (ft)	10.5

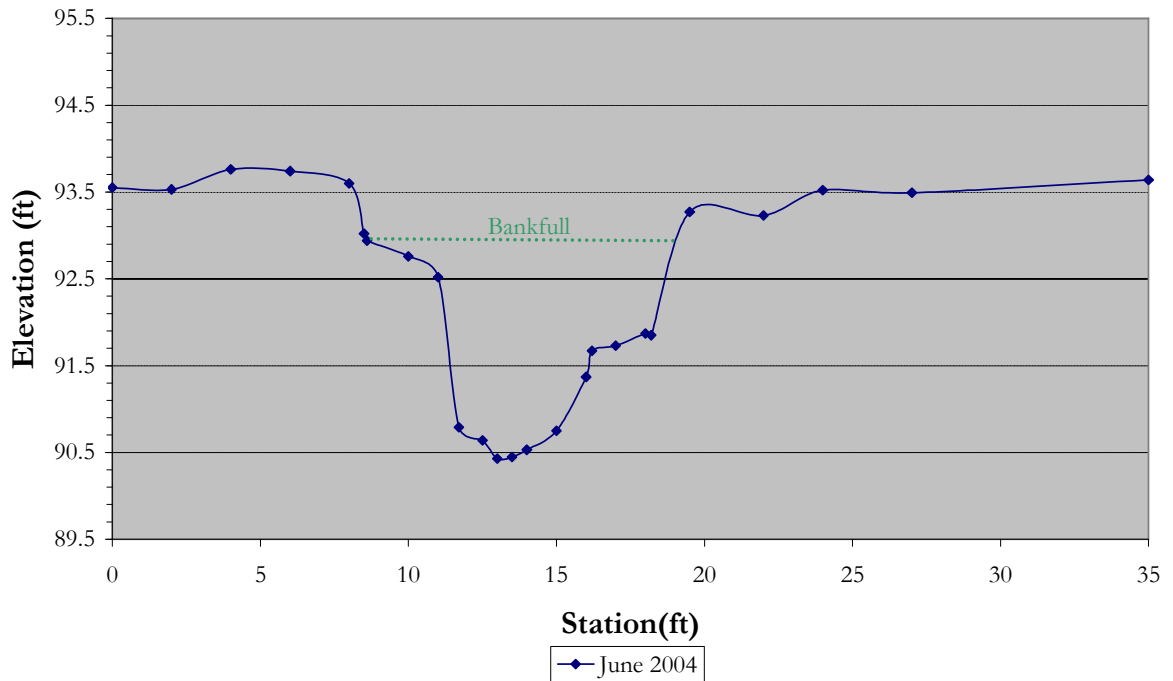
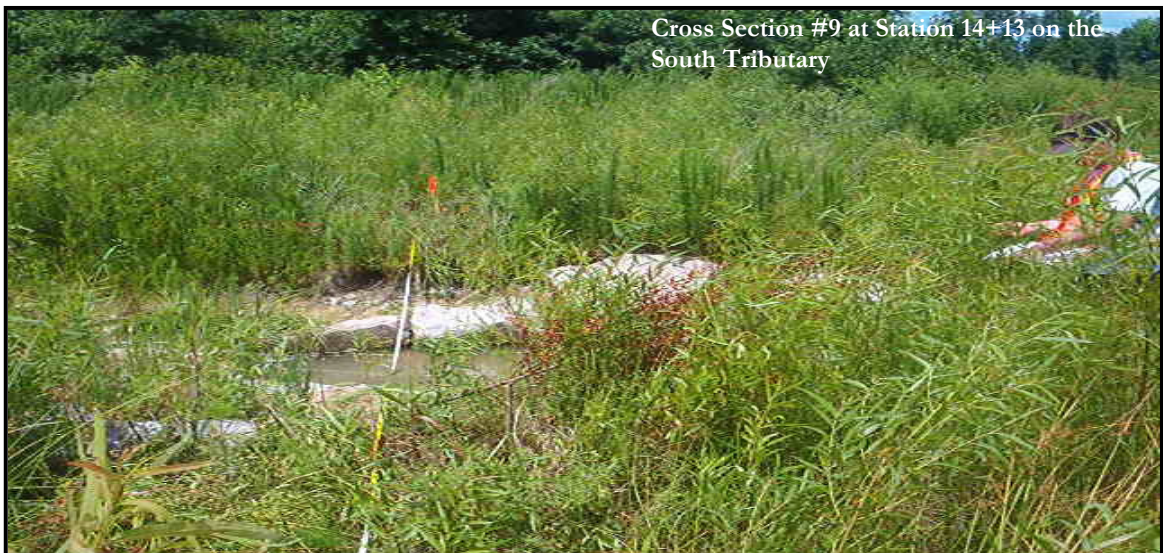
Cross Section #9, Station 14+13 (South Tributary)

2004	2005	2006	2007	2008
Bankfull Cross Sectional Area (ft ²)	8.5				
Maximum Bankfull Depth (ft)	2.5				
Bankfull Mean Depth (ft)	0.8				
Bankfull Width (ft)	10.6

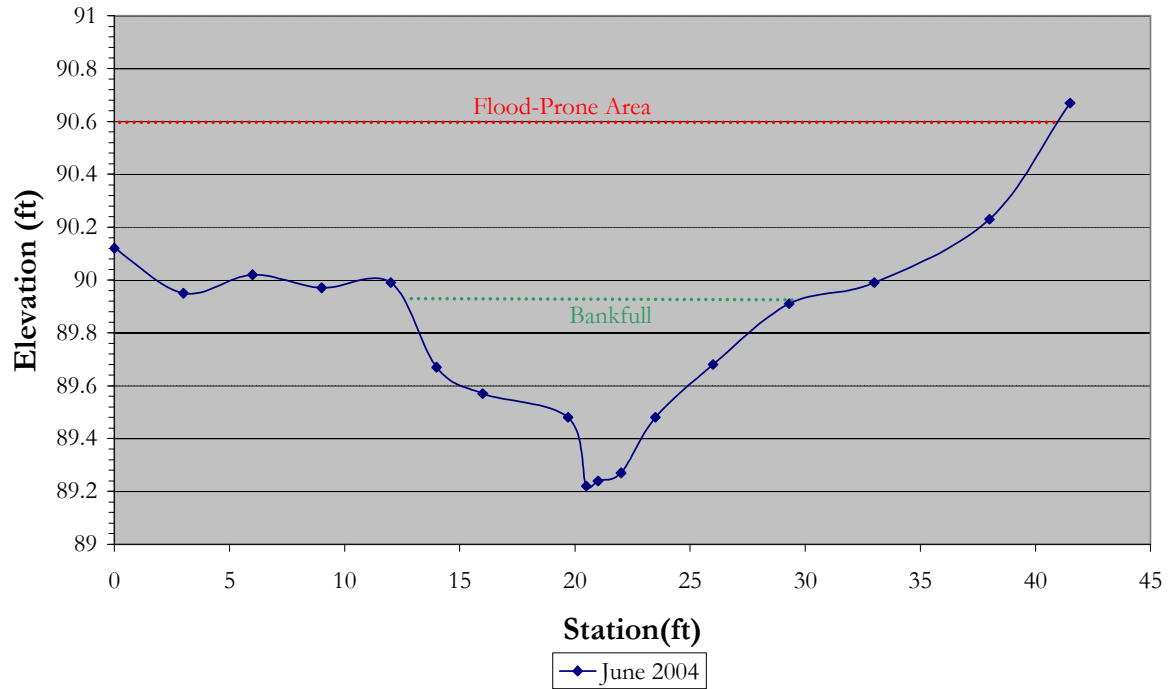
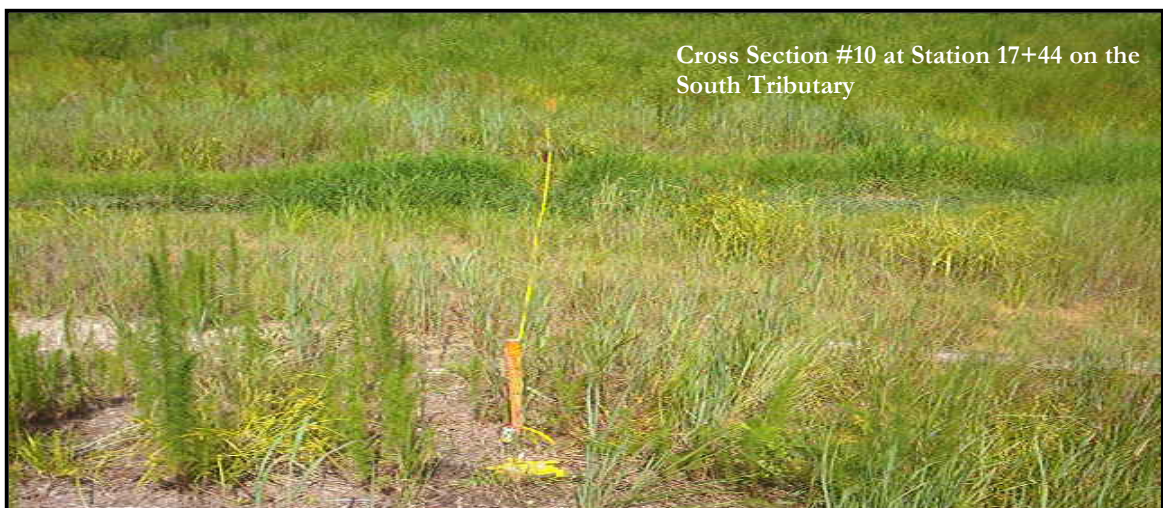
Cross Section #10, Station 17+44 (South Tributary)

2004	2005	2006	2007	2008
Bankfull Cross Sectional Area (ft ²)	5.0				
Maximum Bankfull Depth (ft)	0.7				
Width of the Floodprone Area (ft)	450				
Bankfull Mean Depth (ft)	0.3				
Width/Depth Ratio	56.0				
Entrenchment Ratio	26.8				
Bankfull Width (ft)	16.8

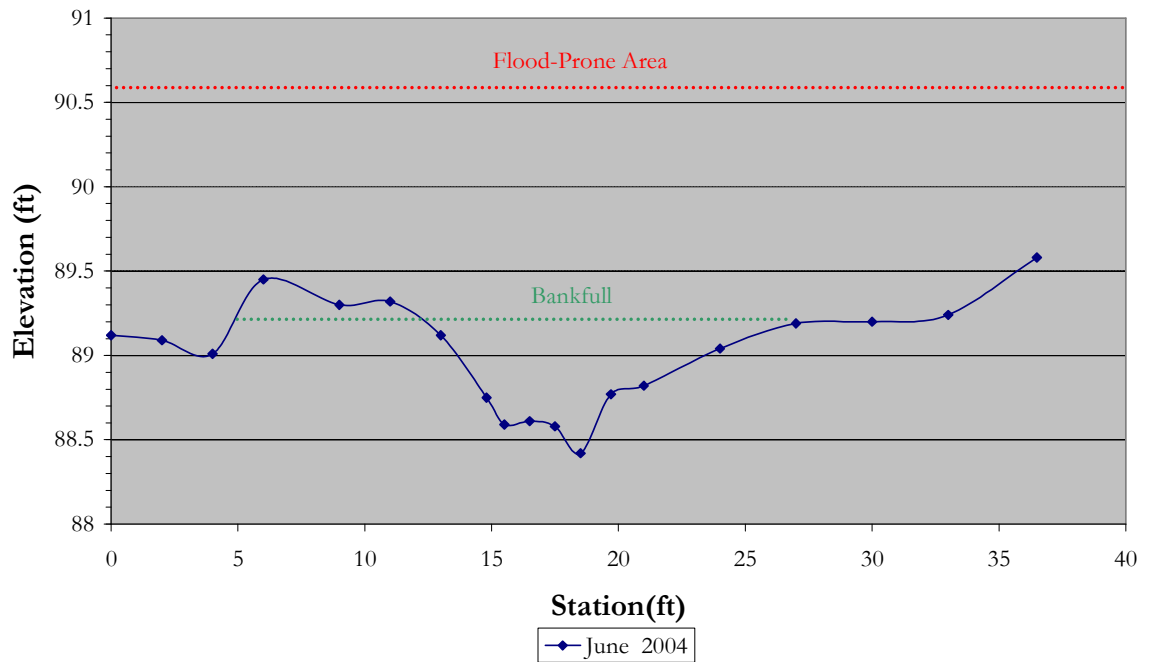
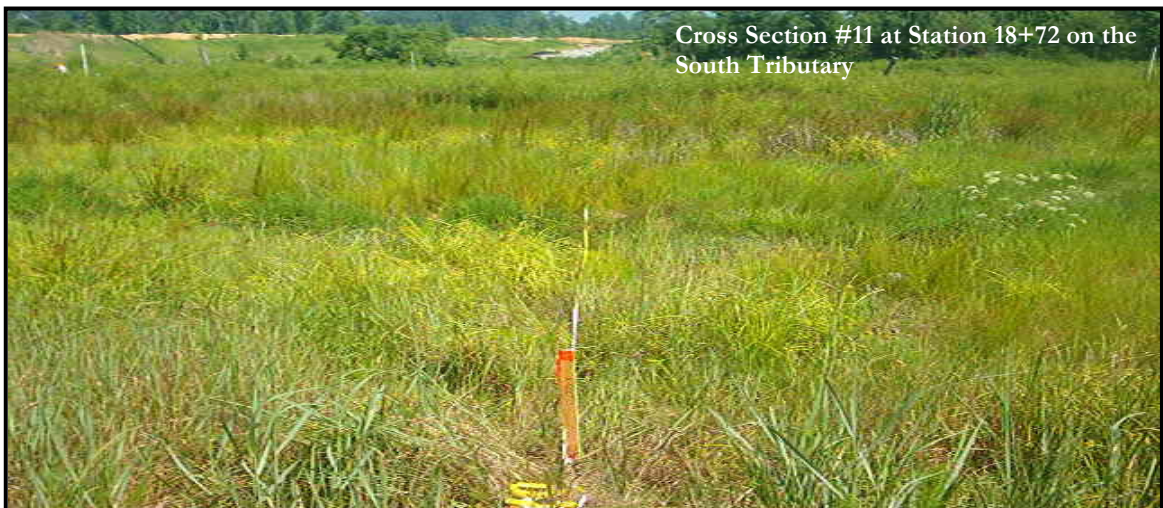
Cross Section #11, Station 18+72 (South Tributary)

2004	2005	2006	2007	2008
Bankfull Cross Sectional Area (ft ²)	4.4				
Maximum Bankfull Depth (ft)	0.8				
Width of the Floodprone Area (ft)	150				
Bankfull Mean Depth (ft)	0.3				
Width/Depth Ratio	49.0				
Entrenchment Ratio	10.2				
Bankfull Width (ft)	14.7

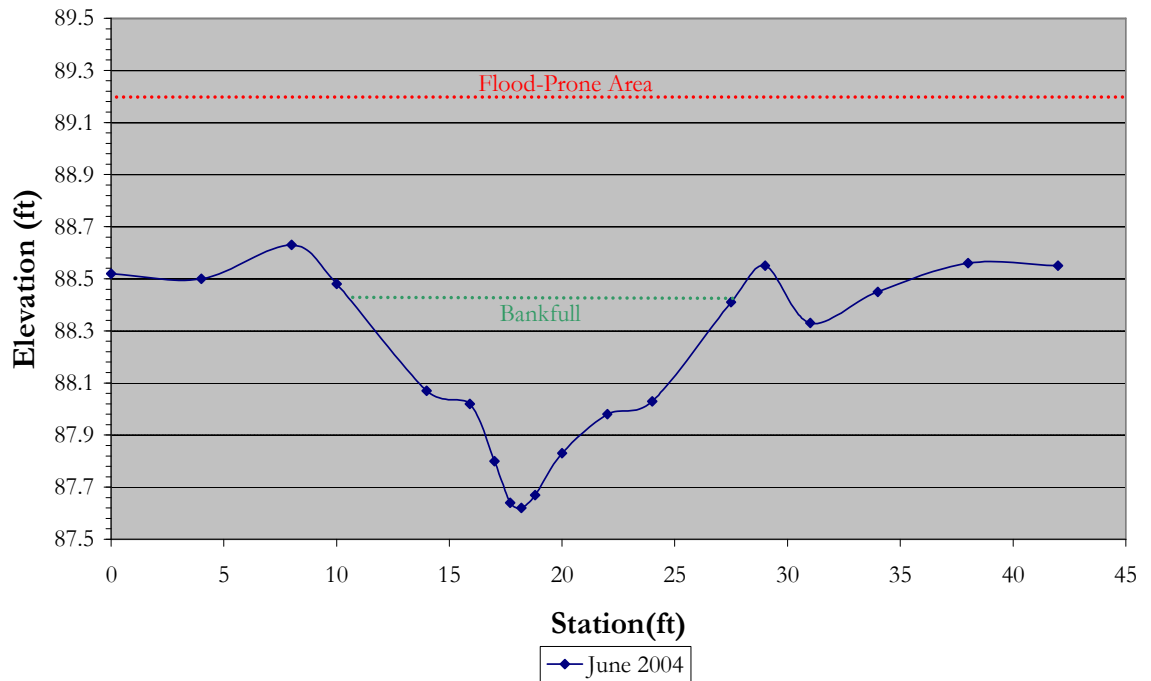
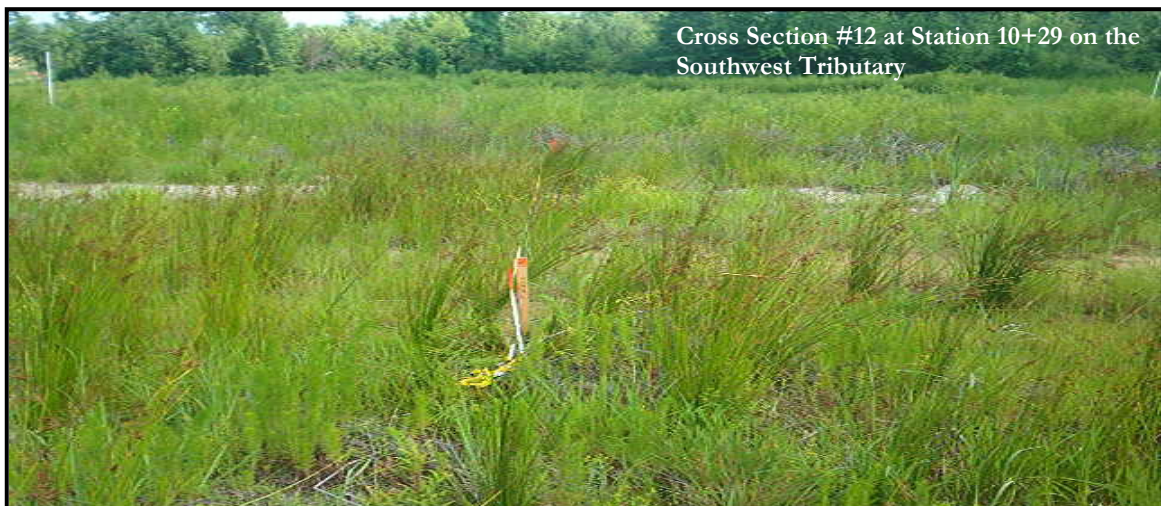
Cross Section #12, Station 10+29 (Southwest Tributary)

2004	2005	2006	2007	2008
Bankfull Cross Sectional Area (ft ²)	4.8				
Maximum Bankfull Depth (ft)	0.7				
Width of the Floodprone Area (ft)	375				
Bankfull Mean Depth (ft)	0.3				
Width/Depth Ratio	53.0				
Entrenchment Ratio	23.6				
Bankfull Width (ft)	15.9

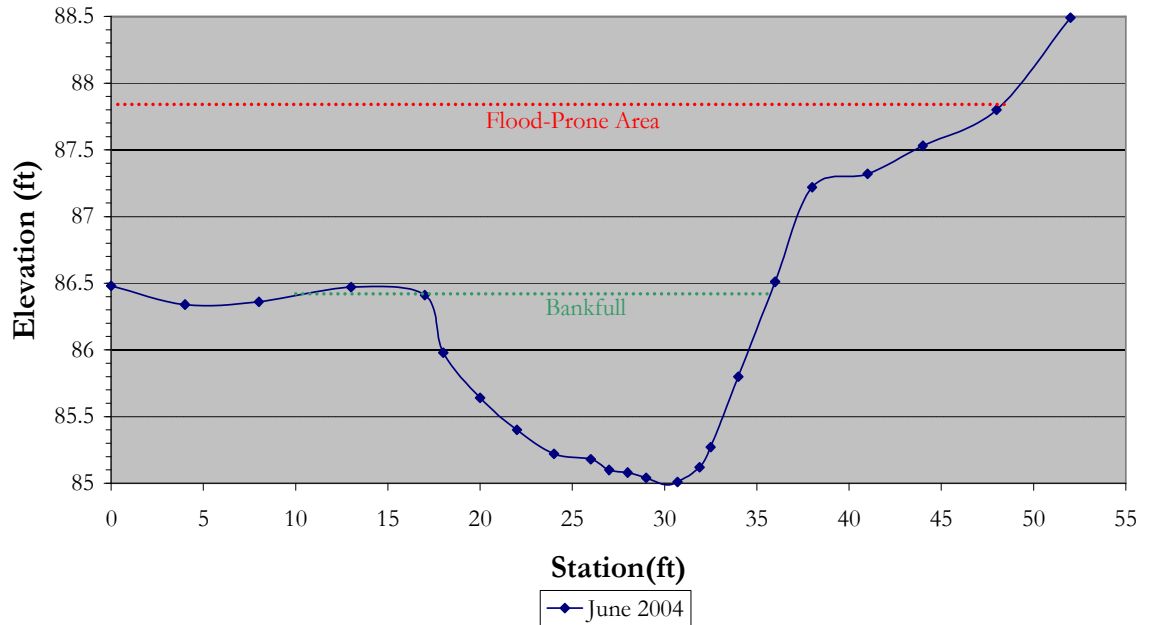
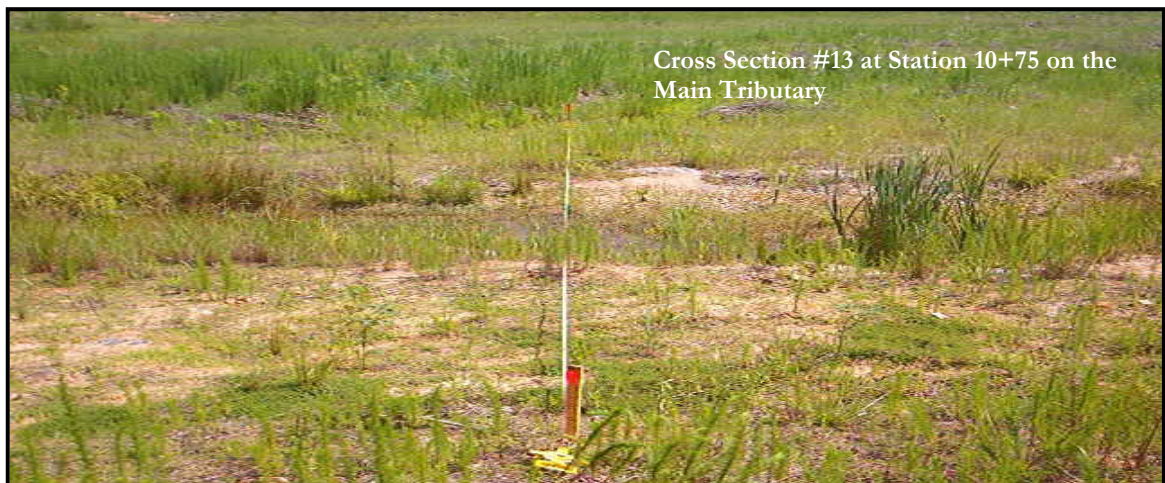
Cross Section #13, Station 10+75 (Main Tributary)

2004	2005	2006	2007	2008
Bankfull Cross Sectional Area (ft ²)	18.7				
Maximum Bankfull Depth (ft)	1.4				
Bankfull Mean Depth (ft)	1.0				
Bankfull Width (ft)	18.7

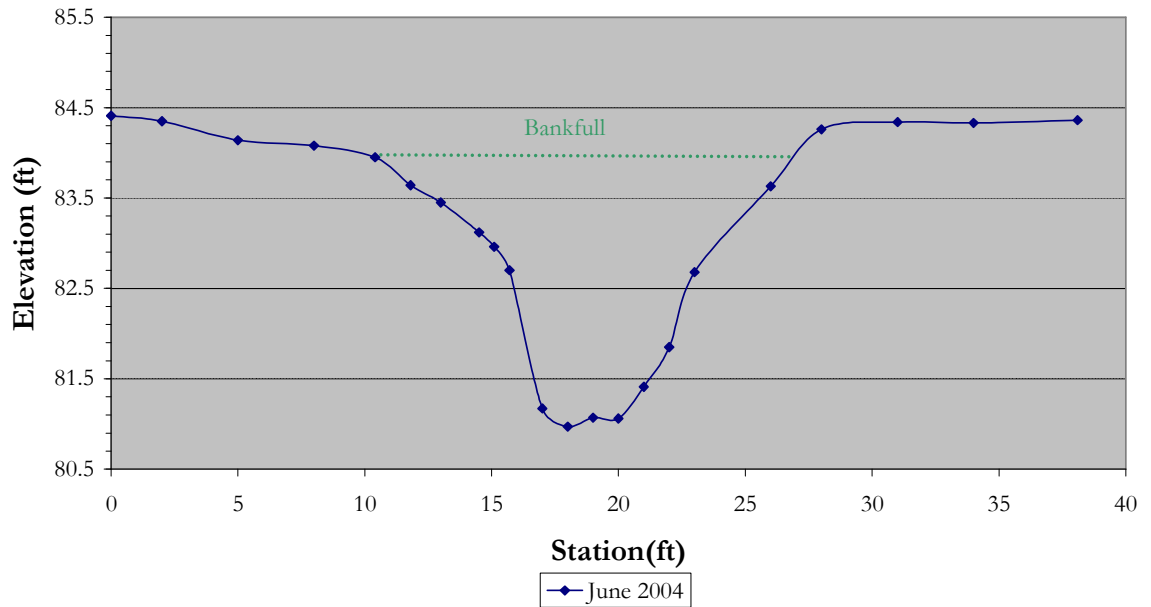
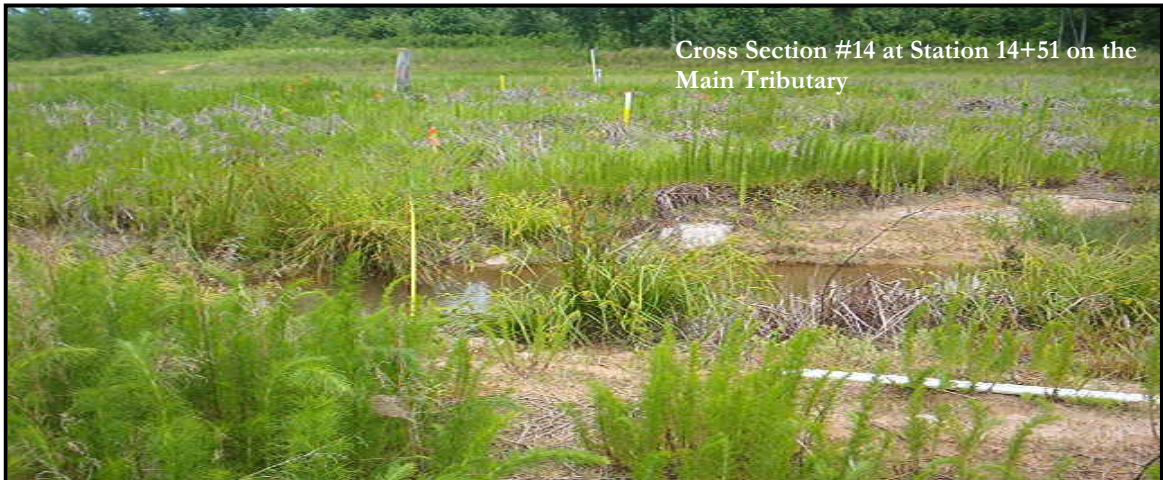
Cross Section #14, Station 14+51 (Main Tributary)

2004	2005	2006	2007	2008
Bankfull Cross Sectional Area (ft ²)	23.2				
Maximum Bankfull Depth (ft)	3				
Bankfull Mean Depth (ft)	1.4				
Bankfull Width (ft)	16.6

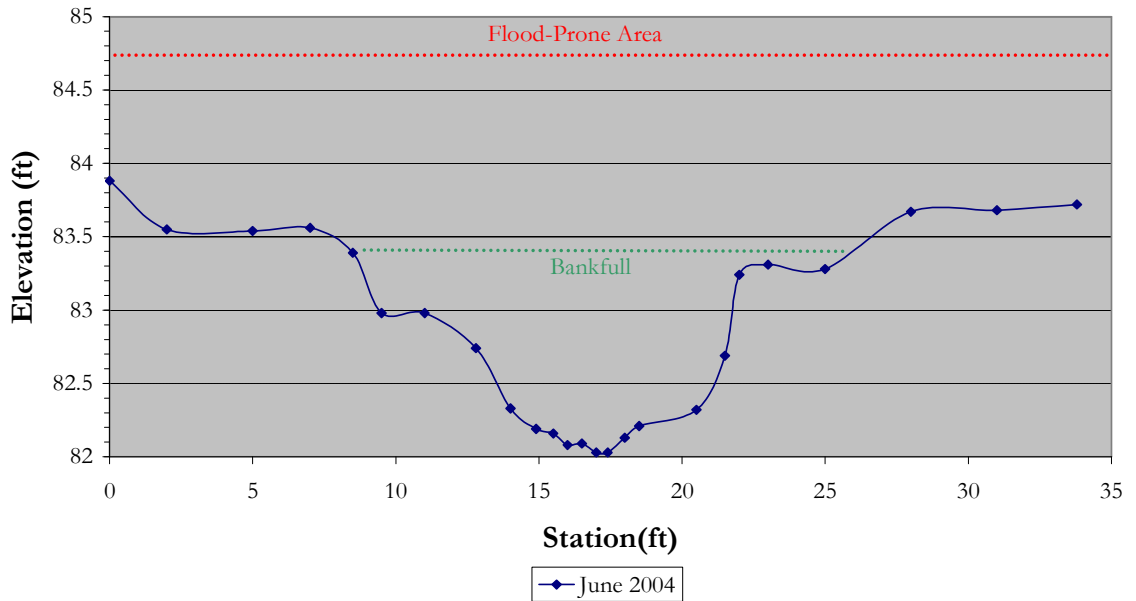
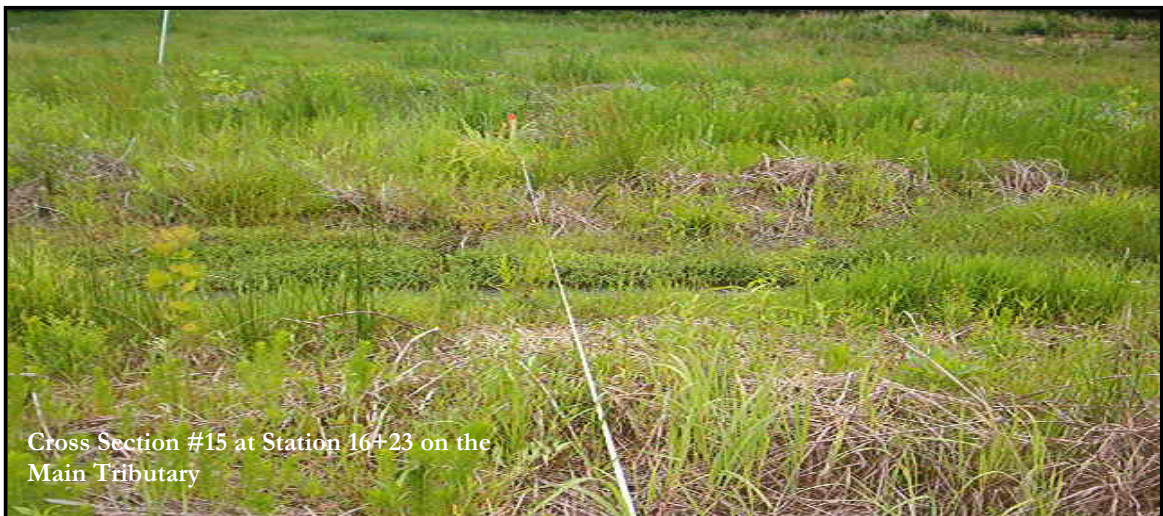
Cross Section #15, Station 16+23 (Main Tributary)

2004	2005	2006	2007	2008
Bankfull Cross Sectional Area (ft ²)	12.1				
Maximum Bankfull Depth (ft)	1.4				
Bank Height (ft)	1.5				
Width of Floodprone Area (ft)	600				
Bankfull Mean Depth (ft)	0.7				
Width/Depth Ratio	24.7				
Entrenchment Ratio	34.7				
Bankfull Width (ft)	17.3

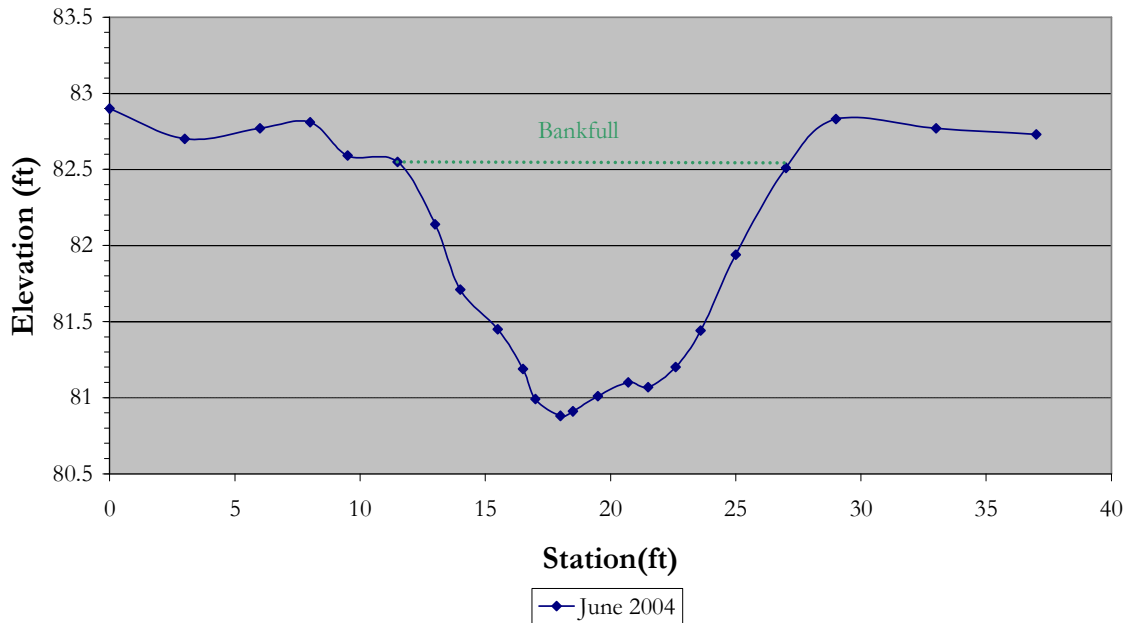
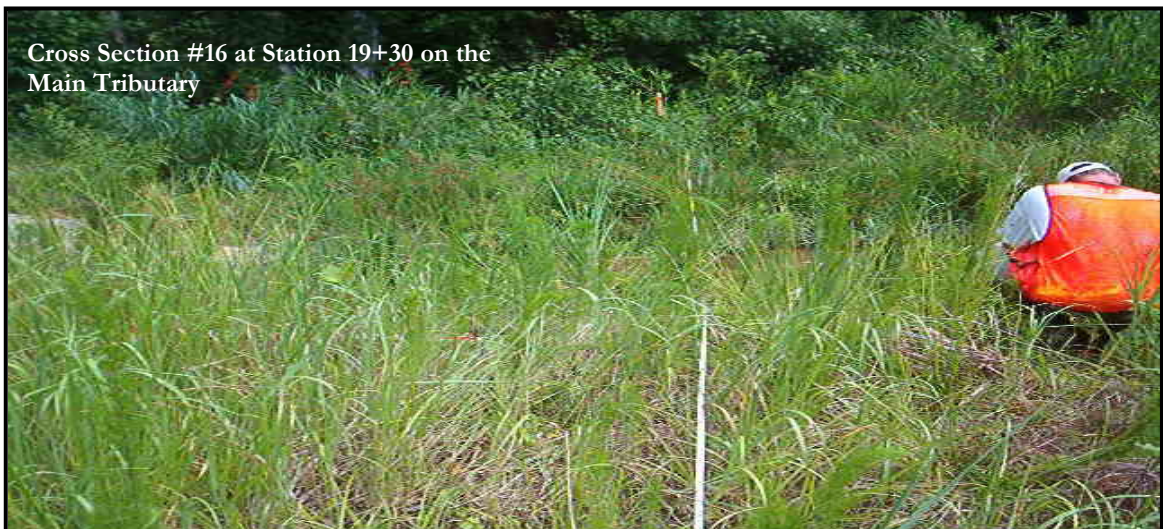
Cross Section #16, Station 19+30 (Main Tributary)

2004	2005	2006	2007	2008
Bankfull Cross Sectional Area (ft ²)	15.8				
Maximum Bankfull Depth (ft)	1.7				
Bankfull Mean Depth (ft)	1				
Bankfull Width (ft)	15.8
